Stoney Beach

Baltimore, Maryland

Walls Protect Development From Flood Waters

CASE STUDY

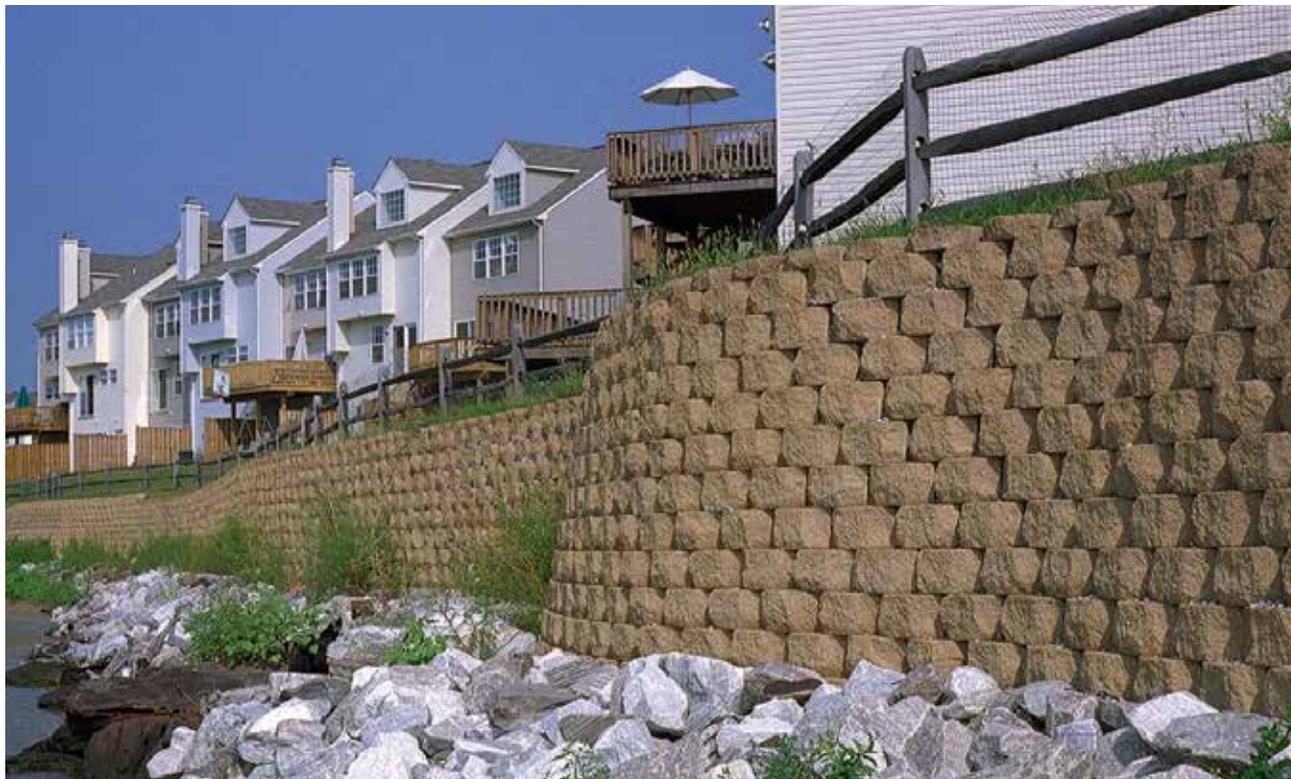
Keystone walls offer an aesthetically pleasing solution at Stoney Beach while providing stability to the shoreline.

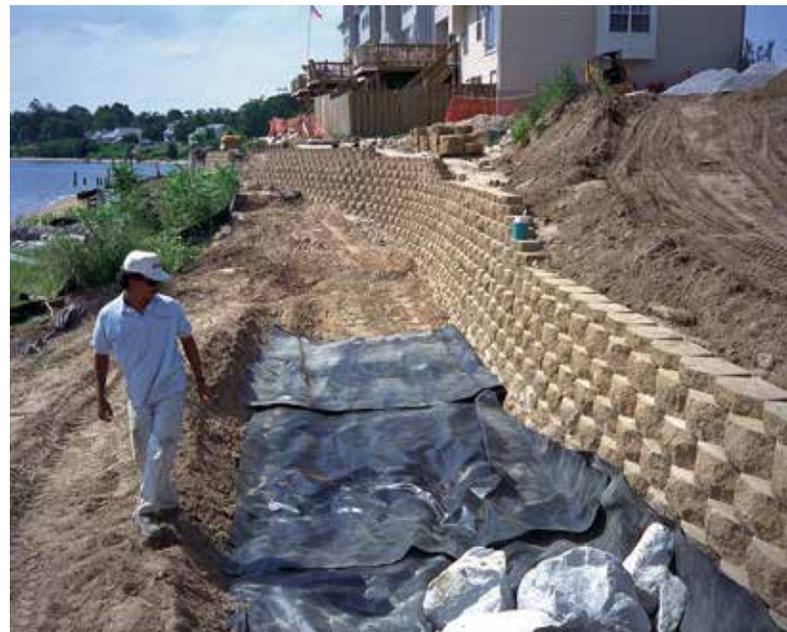
Installing the rip-rap at the base of wall

The 8,400 square foot wall is 900 feet (274m) long with maximum wall heights of nine feet (2.7m). Keystone Standard Units with the tri-plane rockface texture were used on the project. They were placed on 3 feet (0.9m) of compacted 3/4" (20mm) gravel to overcome a soft base sub-soil condition. The project used approximately 3,000 square yards of Mirafi 5T & 7T with embedment lengths between 9 and 10.5 feet (0.9 - 3.2m). The wall design also called for four feet (1.2m) of free draining gravel behind the wall to provide release of hydrostatic pressures caused by flooding. 700 tons (635,000 kg) of armor stone (rip-rap) was placed in front of the wall to stop the water from eroding the base of the wall.
