Natchez Bluff

Natchez, Mississippi

Keystone Saves Historic Homes From Failing Bluffs

32' High Keystone Wall solves the historic “Natchez Bluff” problem!

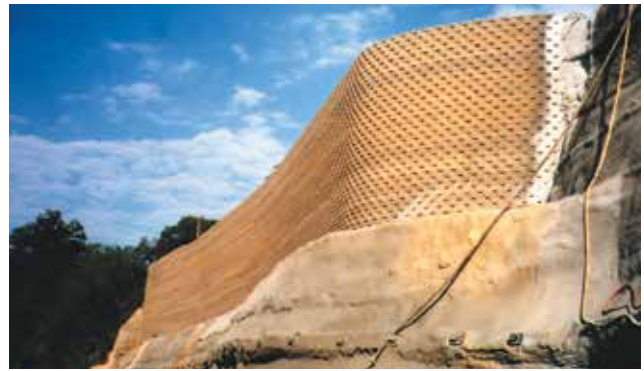
View of wall with soil nailed "bench" below.

shelf 25' out toward the river from the stabilized wall. The section above this bench was cut back 10' (3.0 m) and the remaining area was stabilized with geogrid soil reinforcement and filled with 6,000 pounds of lightweight aggregate, topped with sod and plants. One sidewall of the section is the original bluff, and the back wall of the section is the shotcrete-covered soil-nailed wall.

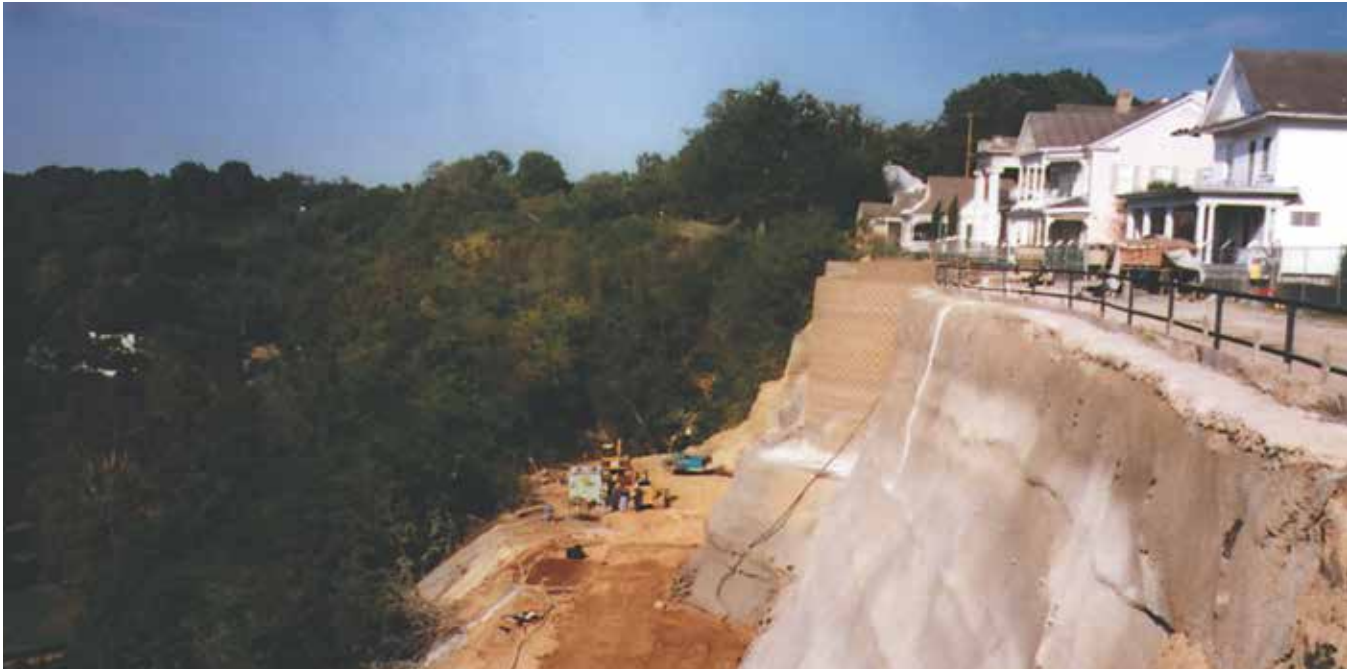
The top of the Keystone wall provides new front yards for bluff homeowners.
